Scientific Investigation of a Fatal Bicycle Ride to School¹

William Wilson

Cook County Sheriff's Police Forensic Laboratory*

A young girl died while riding her bicycle to school one day. Investigators determined that her death was a result of a fall from her bike. A scientific analysis of microscopical evidence and bloodstain patterns strongly indicated another conclusion.

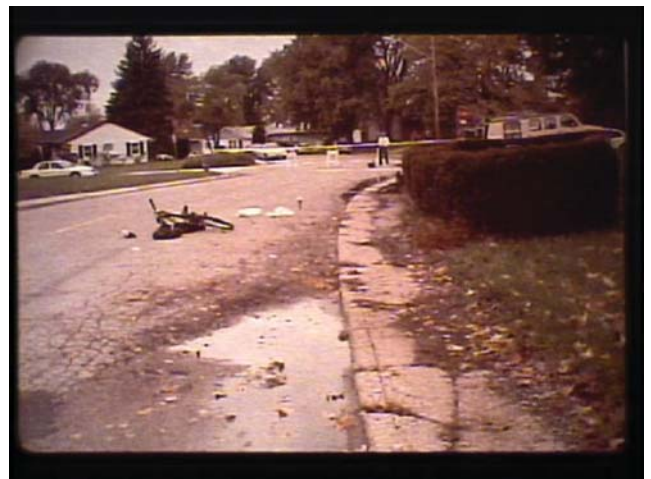
Figure 1. Looking west toward bicycle with intersection in distance.

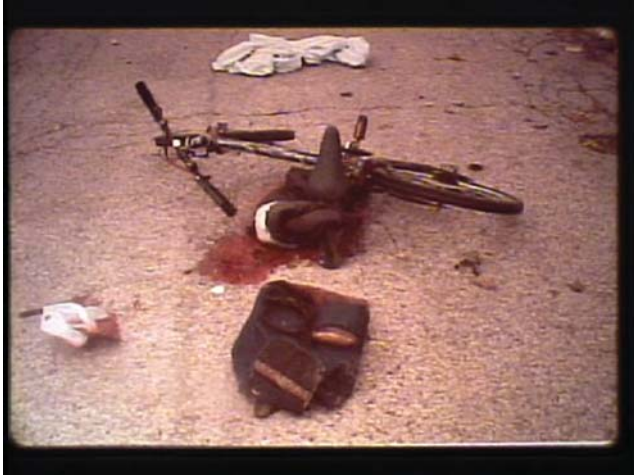
Figure 2. View of bicycle in street over blood with cap, jacket, and backpack.

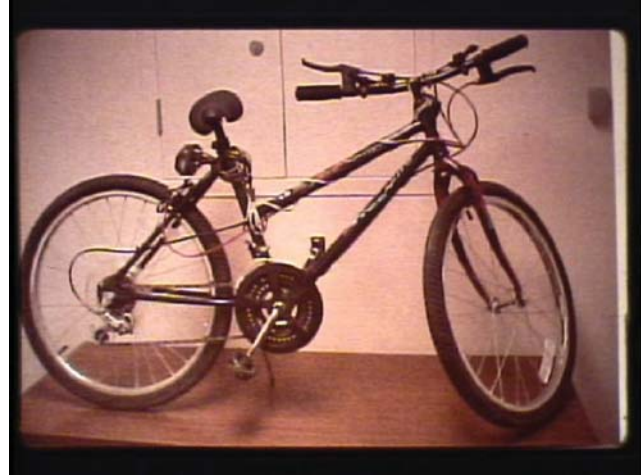
Figure 3. Bicycle in police station.

facing the typical straight-ahead (north) position, was turned 90° to the right and faced the east position. Some type of force was obviously involved for this to happen, but apparently, this fact was not considered in the officials' final conclusion.

The bicycle, clothing, and backpack were transported to the police station and logged in as evidence. Figures 3 and 4 are photos taken of the bicycle; in addition to the pictures showing the bicycle seat turned perpendicularly, Figure 4 clearly shows a drop of blood having fallen, striking the chrome-plated turn signal switch and dripping forward. Despite this and other physical evidence, the police and county coroner continued to maintain that Kristie had died as a result of having fallen off of her bike.

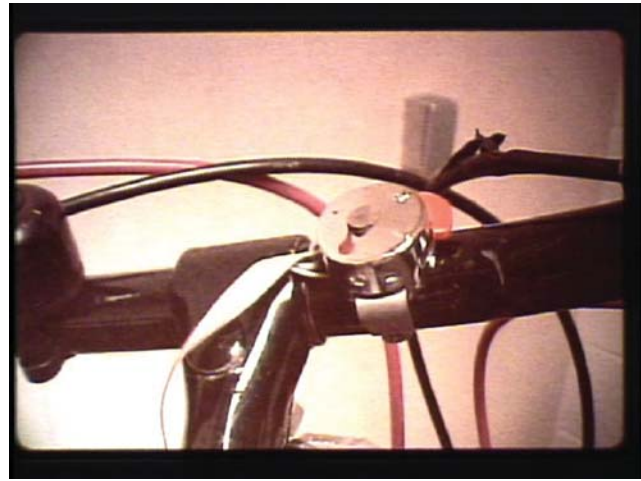
Figure 4. View of bicycle turn signal switch with bloodstain.

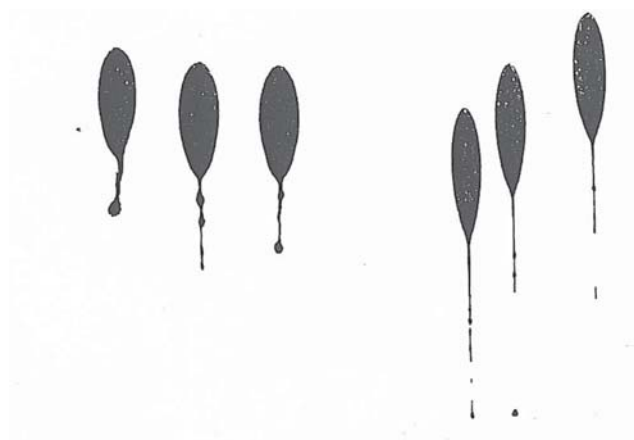
A review of the basic principles of bloodstain pattern analysis is essential here. Blood, as is the case with all liquids, does not fall through the air in a "teardrop" form, but rather in an undulating spherical shape, similar to that of a round water balloon. Competing forces called surface tension (on the outer surface of the drop) and internal cohesion¹ hold the falling liquid together until it either lands on a surface or external force is applied to it, the latter causing it to break apart into innumerable tiny droplets. The more force that is applied, the smaller the resulting droplets will be. The direction of flow can be determined by the resultant shape of the drop; the tail, or the narrowing lower portion, indicates which way the blood was flowing at the time it struck the target surface² (Figure 5). The determination of this direction may be important

Figure 5. Numerous bloodstains demonstrating direction of downward travel.

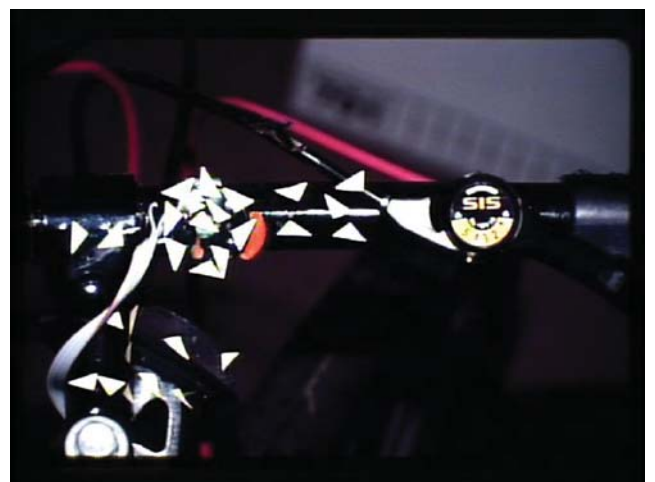
The first item we examined was the bicycle. Figure 6 shows a representative sample of what we encountered: not only was there a larger bloodstain on the chrome turn signal switch, but many other smaller stains scattered on the handlebars, frame, and reflector, indicated by the triangular arrows. Since the distribution of the blood was undoubtedly affected by gravity and force, it was an obvious conclusion that the source of the bloodstains must have been above the bike before it fell onto the street.

Figure 6. Photo of arrows indicating bloodstains on handlebars.

4) Blood drops found on the clothing and bicycle proved that the bike was upright at the time the force was applied and that the blood was shed almost instantly after Kristie was struck; and

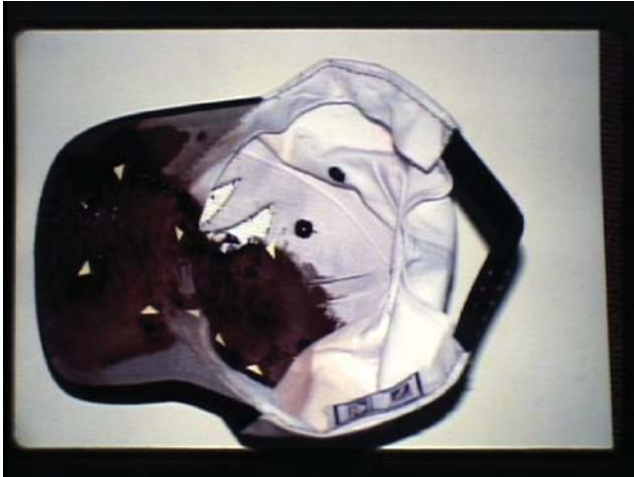
Next, we studied Kristie's ball cap (Figure 7). The right side of the bill of the cap demonstrated a buckle or indented edge. Inside were bloodstains and several Caucasian head hairs, denoted by the triangular arrows. A microscopical examination of the roots of these hairs revealed that each was in their anagen stage³, indicating that they were forcibly removed from the scalp and were not naturally shed. If Kristie were

wearing the cap backwards on her head at the time of the accident, then these two factors indicated that some sort of force was applied to the back of her head at some point prior to her falling.

Figure 7. Underside of cap with arrows indicating pulled head hairs. The buckled right edge of the bill is evident.

2) The forcibly removed hairs found inside the cap and buckled bill supported the hypothesis that the victim was struck in her rear head/neck region;

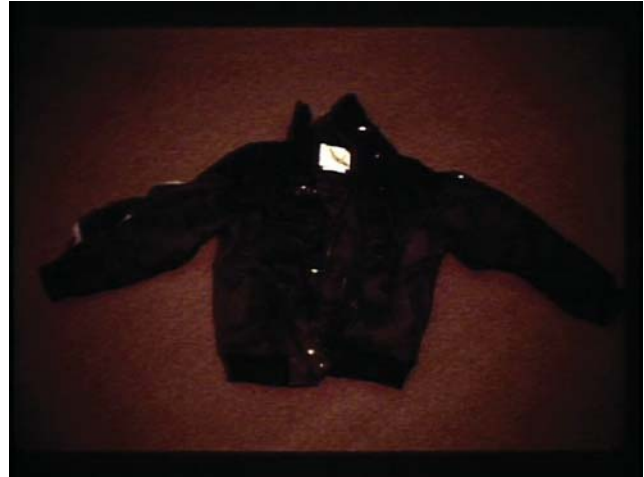
Kristie's leather jacket, which was cut off her body by paramedics at the scene, can be seen in Figures 8 through 10. The bloodstains seen at the right shoulder and the top snap were damaged due to handling, but all bear the unmistakable appearance of having flowed downward, since the tails of each stain are lower and all point down. This confirmed our hypothesis that the source of the blood originated from above and occurred some time before Kristie and the bicycle fell to the ground.

Figure 8. Overall view of victim's jacket.

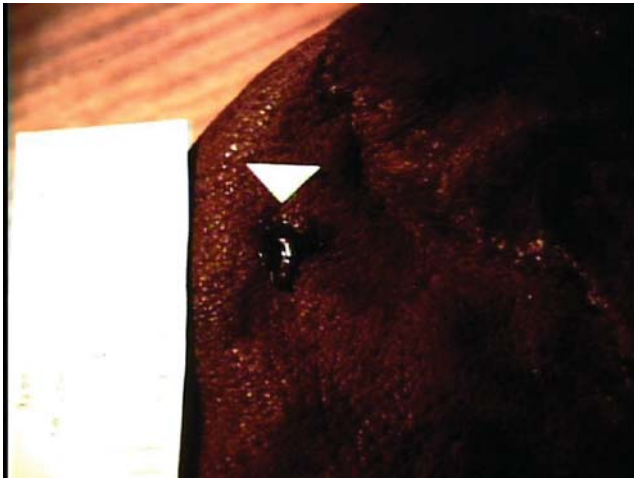
Figure 9. Right shoulder of jacket with arrow indicating direction of blood drop.

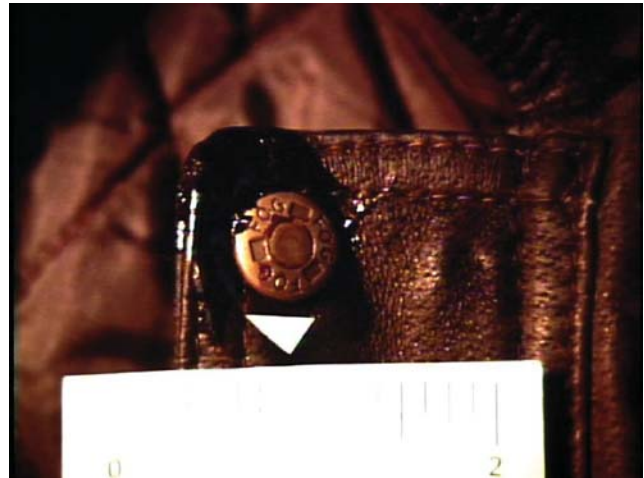
Figure 10. Top snap of jacket with arrow indicating direction of blood drop.

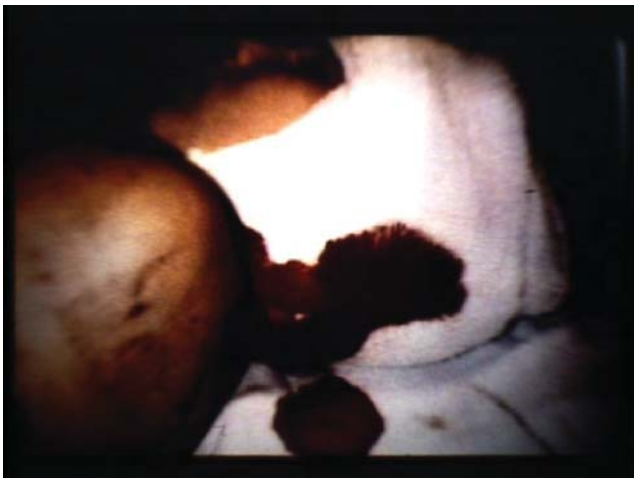
At this point, the existence of other photographs (Figures 11 through 13) of the victim surfaced. It is not uncommon for "new" evidence to be "discovered" during the course of an investigation, and this case proved to be no exception. Figure 11 is a Polaroid and depicts the victim after she was bandaged up by the paramedics at the scene, as she was being loaded onto the ambulance. It is apparent that the gauze and kling used to wrap Kristie's head is thoroughly soaked with blood, indicating that her head was the source of the blood. The next two pictures are black and white photographs taken by the local hospital emergency room staff. These clearly show some blood exuding from both ears of the victim, indicating a bilateral blood flow from some type of internal head injury. A review of an anatomy book⁴ revealed that the vertebral artery travels through the spinal column and a rupture

Figure 11. Polaroid of victim showing heavy blood flow on left side of head.

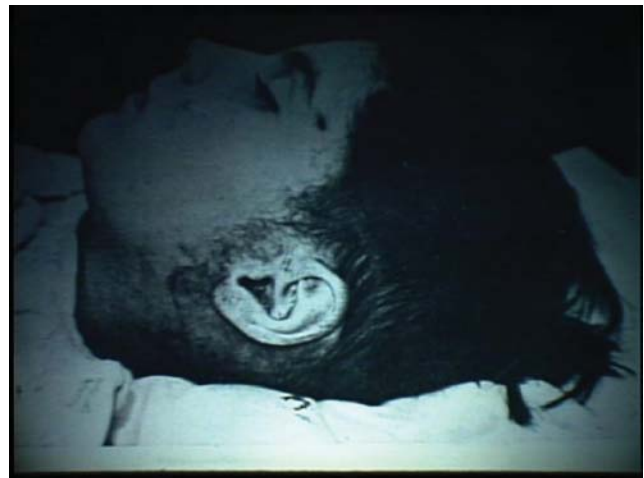
Figure 12. Photo of victim in hospital with blood pooled in left ear.

of this artery (possibly caused by force or a broken vertebrae) could well have been the reason for the blood flow from both ears.

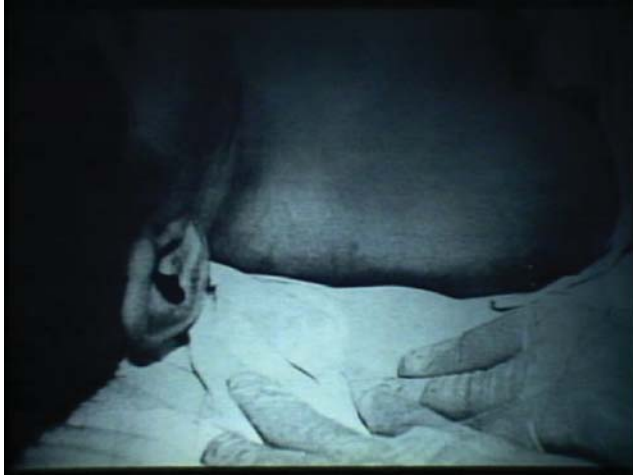
Figure 13. Photo of victim in hospital showing blood in right ear.

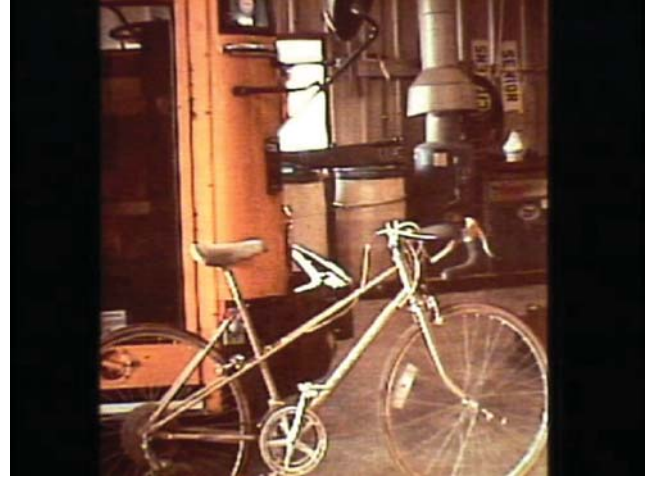
Figure 14. View of another bicycle in relation to bus right side mirror.

5) Clearly, the only reasonable conclusion we could reach that fit all the facts was that the school bus had come in contact with Kristie, breaking her neck and killing her instantly. Several photographs of the school bus taken at a later date (depicted in Figure

14) show the side view mirror extending out from the right windshield area and demonstrate the mechanism by which we believed that the bus most likely struck Kristie while she rode her bike to school.
